Minutes of the soil degradation risk simulation

Simulation and economic evaluation of the plan to manage soil degradation risk in forestry

**Quinta do Furadouro
(Óbidos) and Vale de
Mouro , Portugal
3-4 December 2018**

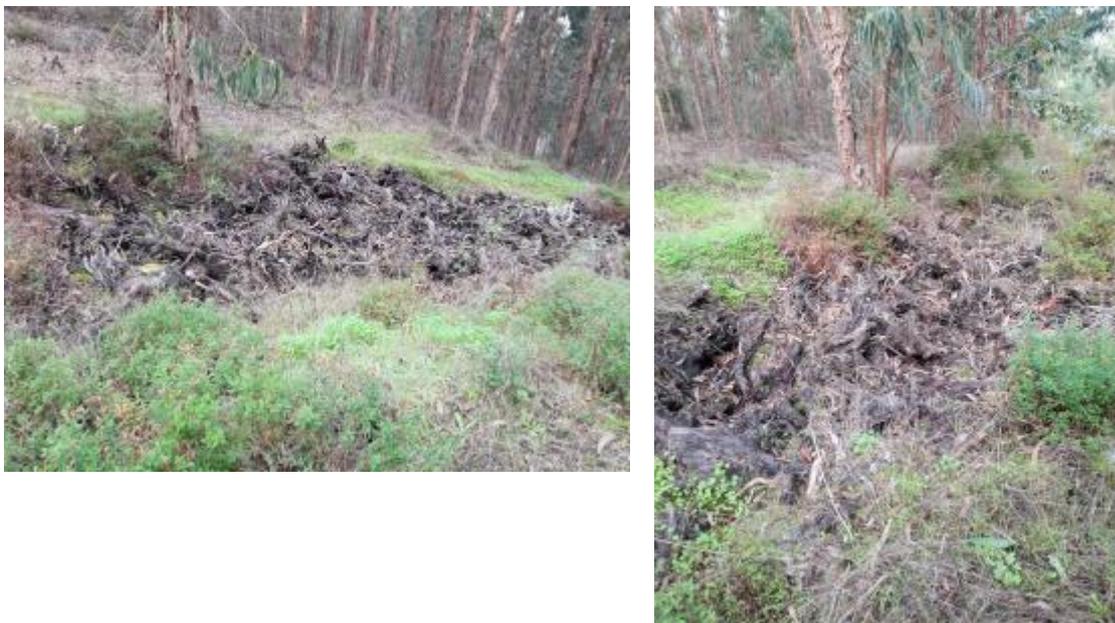
Fig 3. Some rehabilitation measures using eucalypt stumps to fill erosion rills and to prevent further erosion to occur. (Pict. by Ander Arias-González)

A field visit was organized to Vale Mouro by Altri to show the place where the big erosion event took place and the rehabilitation and restoration measures taken.

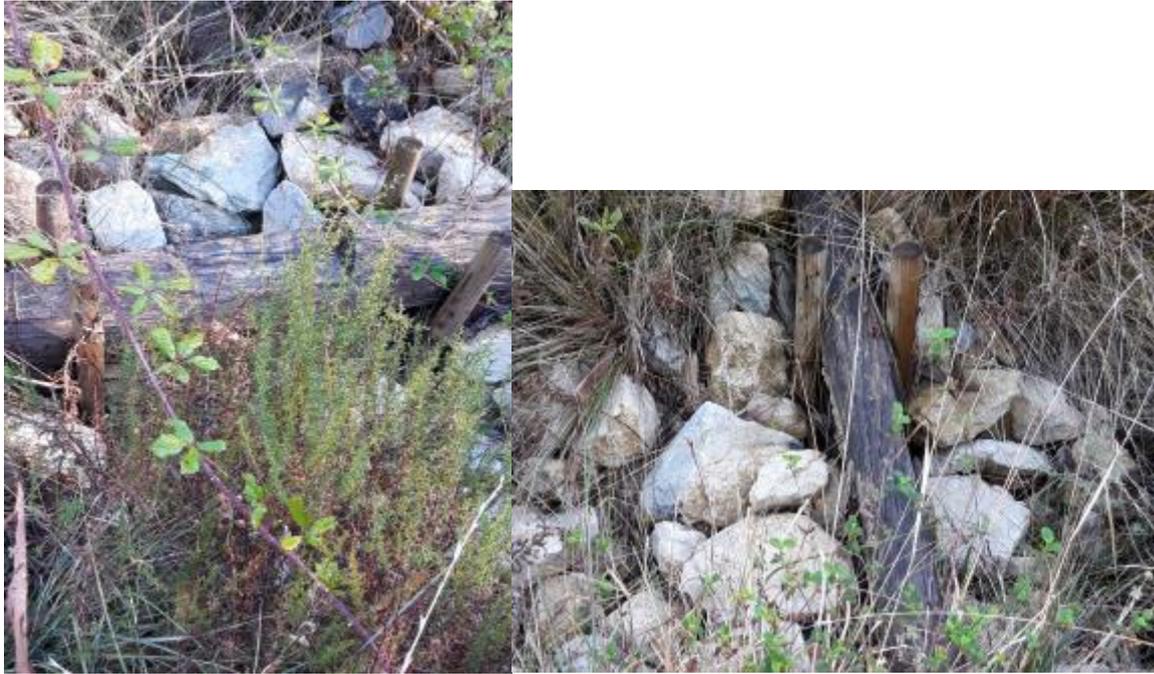
Fig 4. Some rehabilitation measures consisting in branches held with sticks and stones to prevent further erosion. (Pict. by Ander Arias-González)

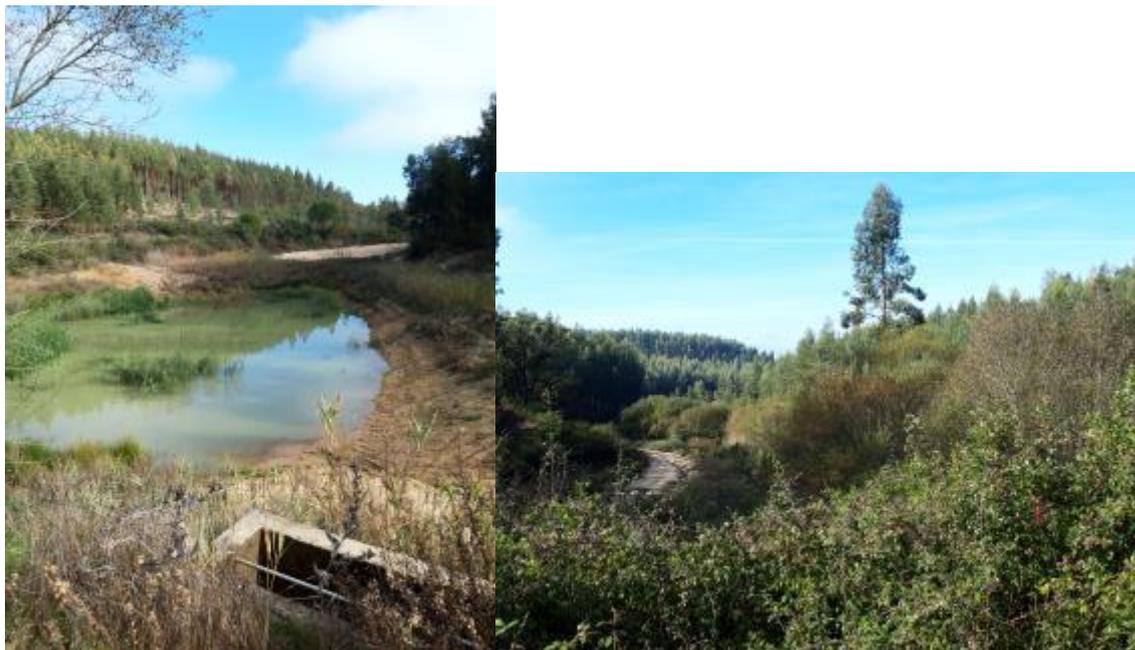
Fig 5. Some environment restauration measures aiming at improving biodiversity in eucalypt plantations consisting in the construction of several ponds as a water source for terrestrial wildlife, amphibian reproduction and invertebrates in general and *Salix* sp. plantation along the watercourse that crosses the stand to improve water quality and to act as an ecological corridor. (Pict. by Ander Arias-González)
